METALS HANDBOOK

VOL. 9
FRACTOGRAPHY AND ATLAS OF FRACTOGRAPHY

8th EDITION

Fractography and Atlas of Fractographs

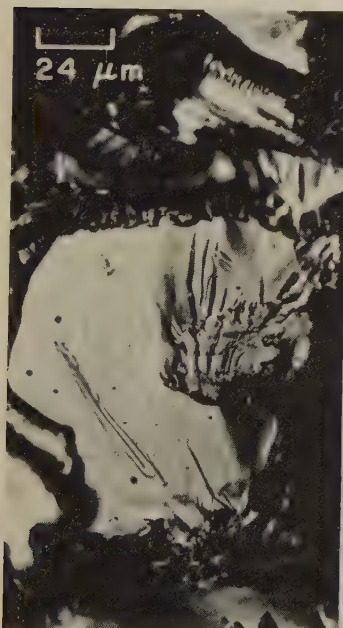
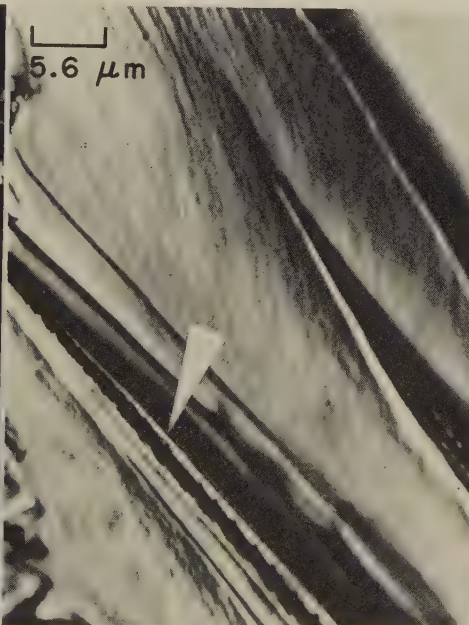
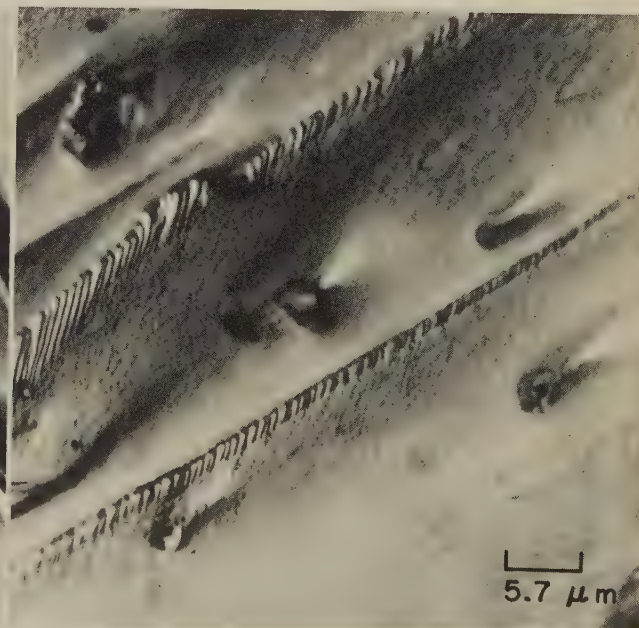
Light fractograph 420× Light fractograph 1775× Light fractograph 1765×
3521, 3522, 3523 Surfaces of impact fractures in three specimens of an iron-silicon alloy (0.052% C, 18.10% Si) that were taken from a 5-lb laboratory ingot and broken at room temperature. Fractograph 3521 (left) shows a typical cleavage facet in the epsilon phase (FeSi). The fracture behavior is glasslike. Fractograph 3522 (center) exhibits features (such as the one at arrowhead) with an unusual needlelike form, embedded in ferrite dendrites. These features are believed to be solid-state precipitates, possibly the eta phase (Fe_5Si_3). Fractograph 3523 (right) shows unusual parallel ridges with edges containing lamellae of fairly uniform thickness. Very faint fracture-progress markings, particularly at inclusion sites, indicate that the crack front proceeded from lower left to upper right, parallel with the ridges.

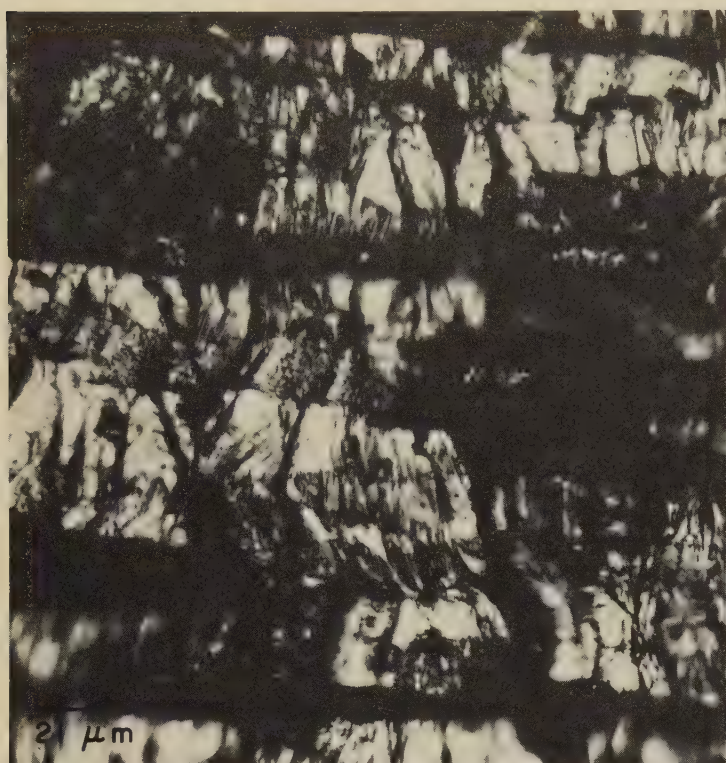
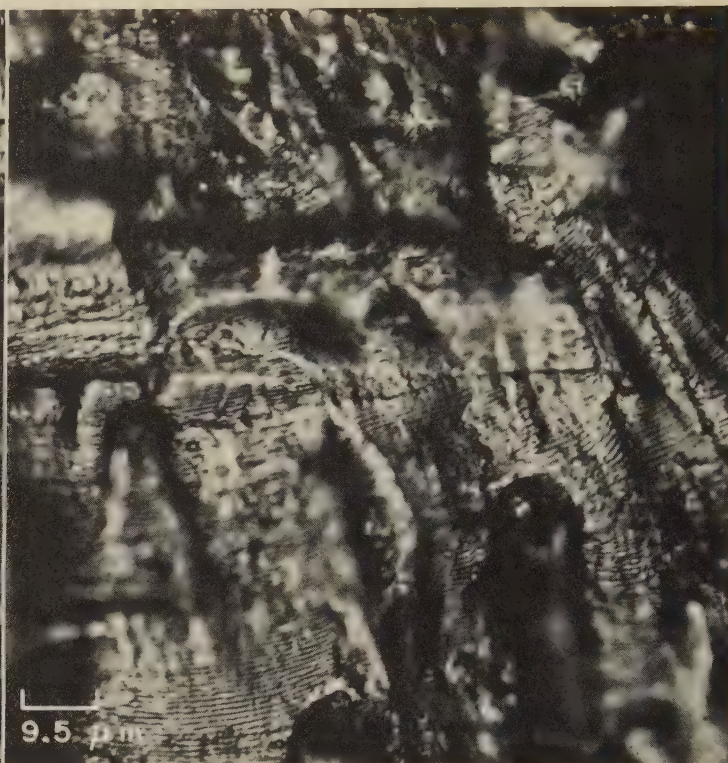
3524, 3525

Two views, at different magnifications, of the surface of a high-cycle fatigue fracture in a specimen of aluminum alloy 7076-T6 cut from a 0.188-in.-thick sheet and tested in completely reversed bending, at a maximum stress of 172 MPa (25 ksi) and at room temperature, to failure at 336,000 cycles. Propagation of the fatigue fracture created strata (possibly the traces of grain boundaries) along planes normal to the bending direction. Fatigue striations can be seen faintly within the strata in 3524 (left) and are clearly visible in 3525 (right), each striation having resulted from one full cycle of bending-stress reversal. See also 3526 and 3527.

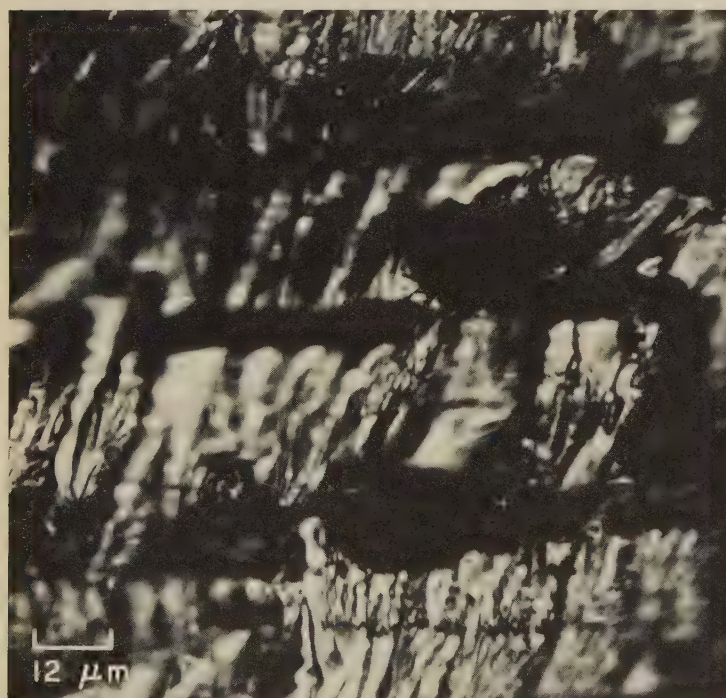
3526

Fracture in the aluminum alloy 7076-T6 specimen in 3524 and 3525, obtained by notching 0.25 in. from the fatigue-fracture surface in those views and breaking by impact at room temperature. Strata like those in 3524, presumed to have been caused by the fatigue test, are present here, but were absent in a similar impact fracture (not shown) 0.60 in. from the fatigue fracture.

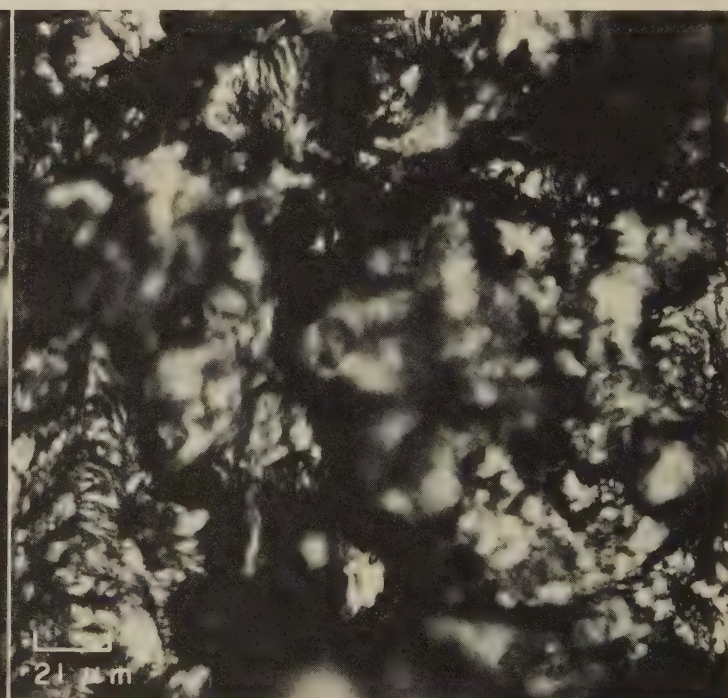
Surface of a low-cycle fatigue fracture in a specimen of the same aluminum alloy 7076-T6 sheet shown in 3524, 3525 and 3526. This specimen was tested in reversed bending at a maximum stress of 310 MPa (45 ksi) and failed at 18,000 cycles. The surface is considerably more distorted than that shown in 3524, but scattered fatigue striations are visible.

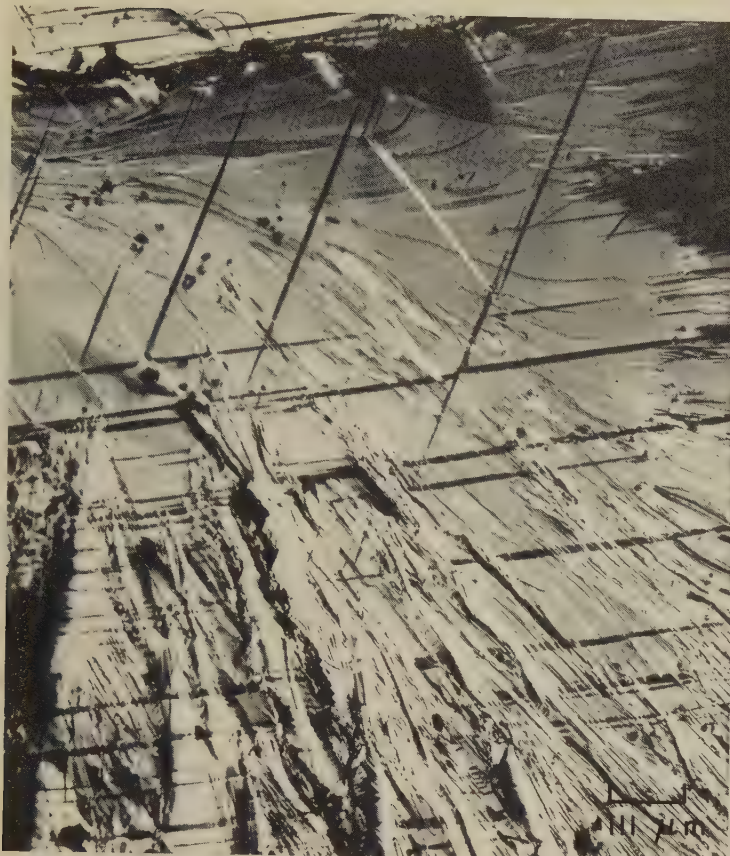
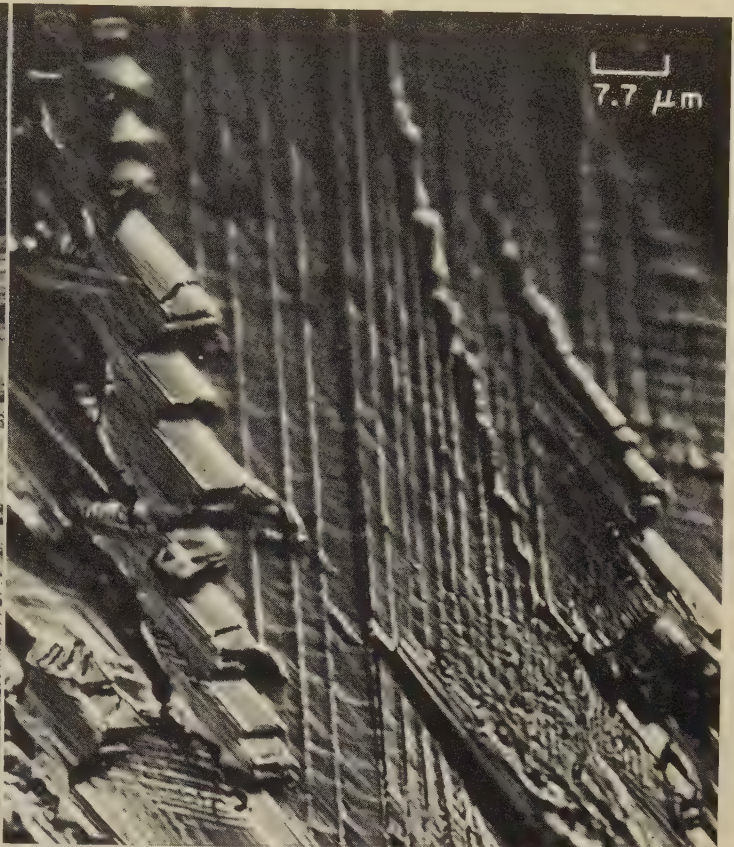
3528, 3529

Two dissimilar regions of the surface of a cleavage fracture produced by impact at room temperature in as-cast polycrystalline antimony (99.83% Sb, 0.04% S, 0.035% As, 0.035% Pb, 0.015% Fe, 0.01% Cu). In the region shown in 3528 (left), the crack front entered at upper left as cleavage on the (0001) basal plane. The three sets of trigonally symmetrical bands with mutual angles of 60° are intersections of the fracture surface by a $\{10\bar{1}4\}$ system of twins. Fractograph 3529 (right) shows the surface of a secondary crack, which contains elaborate detail involving intersecting traces of both $\{10\bar{1}4\}$ and $\{10\bar{1}1\}$ planes (determined by measurement of relative angles). The vertical steps (at left and at right) in this complicated fracture path suggest a mosaic formed by defects.

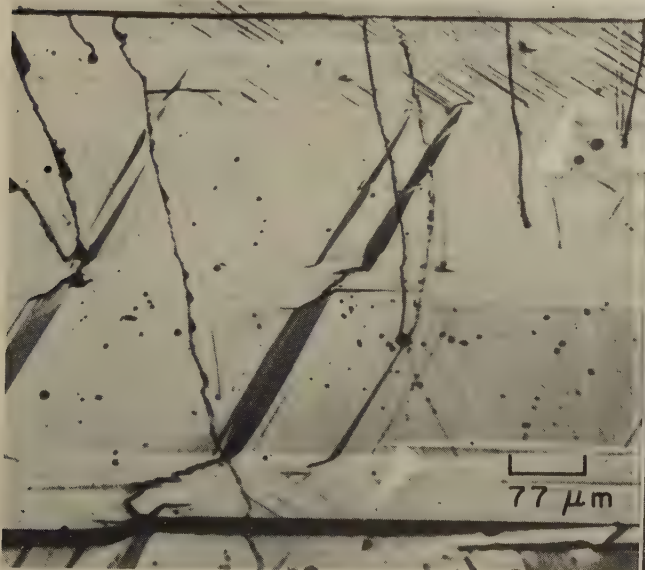
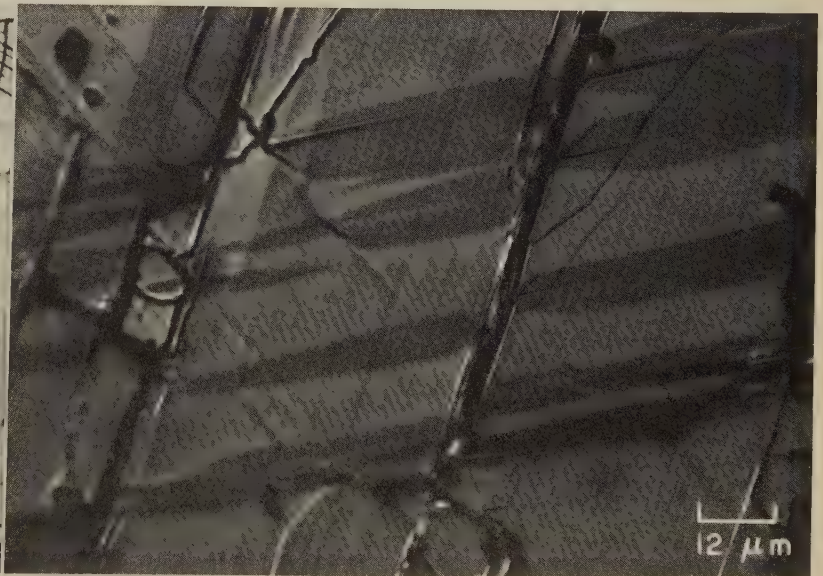
3530, 3531

Surfaces of basal-plane (0001) cleavage fractures produced by impact at room temperature in two specimens of the same polycrystalline antimony as in 3528 and 3529 (above). Fractograph 3530 (left) shows a fracture in as-cast material, which is characteristic of fractures produced in this material at temperatures within the range of -196°C (-321°F) to 631°C (1168°F). The heavy, dark bands (such as the one at the arrowhead at bottom) are first-order twins, and the fine lines (arrowhead at upper right) are second-order twins, or "twins within twins". The fracture shown in 3531 (right) was produced after the specimen had been heated in helium to 650°C (1202°F) and furnace cooled. As in 3530, the bands were caused by twinning, which occurred on $\{10\bar{1}4\}$ planes.

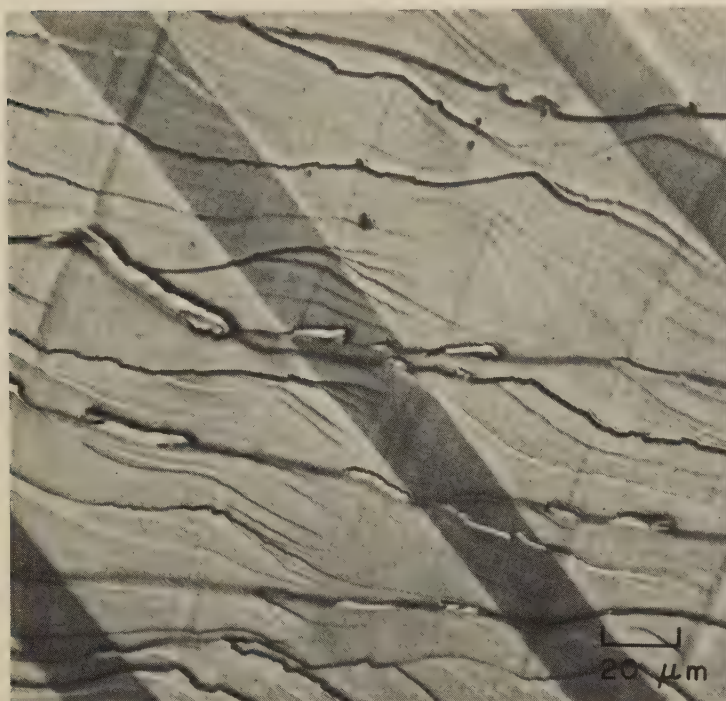
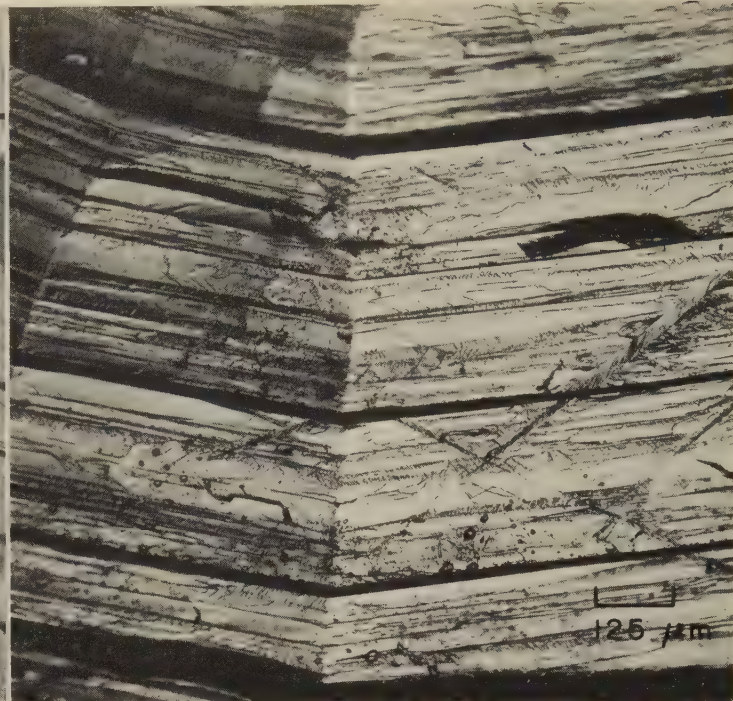
Light fractograph
3532, 3533

Surfaces of room-temperature impact fractures in two specimens of as-cast CP-grade bismuth (99.8% Bi, 0.01% Ag, 0.005% Pb, 0.01% Fe, 0.005% Cu, 0.01% S). Fractograph 3532 (at left) shows a cleavage facet conforming approximately to a basal (0001) plane and showing cleavage steps crossing three parallel twin bands that are remarkably uniform in width. At right (fractograph 3533) is a transverse fracture surface in a specimen that was produced by melting the bismuth in a gas flame, drawing it up into a Pyrex tube, and cooling in contact with the melt. The sharp, roughly vertical discontinuities are radial dendrite boundaries resulting from crystal growth conforming to the curvature of the tube. Angle measurements suggest that this is an (00 $\bar{1}$ 1) facet crossed by {10 $\bar{1}$ 4} twins and {0001} basal planes.

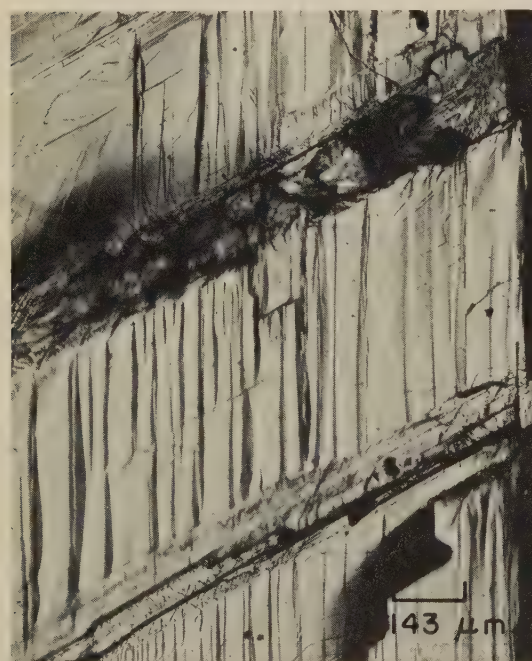
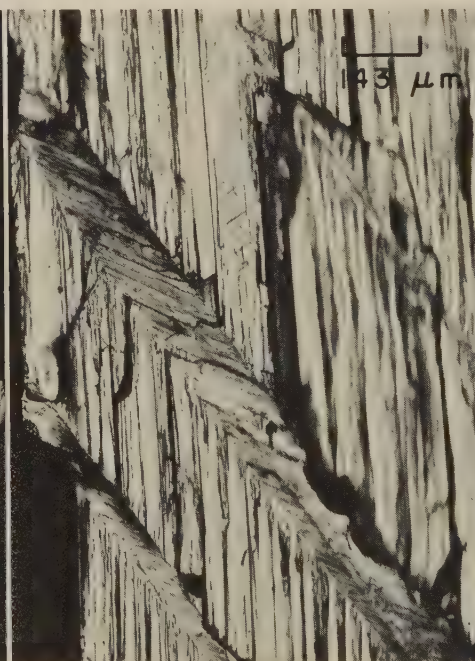
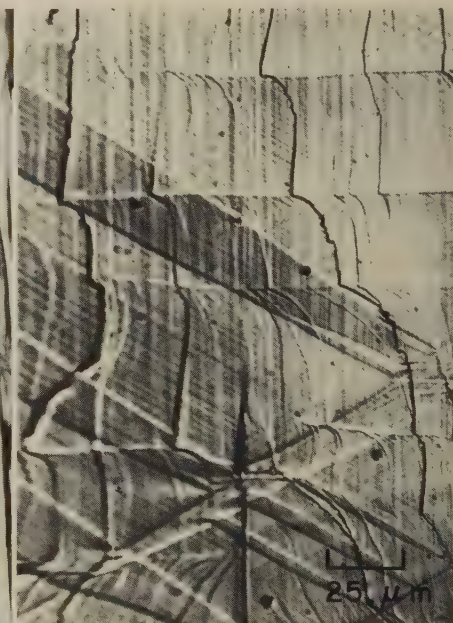
Matched fractographs of two intersecting cleavage facets produced by room-temperature impact fracture of a single grain of CP-grade bismuth prepared to illustrate the identification of crystallographic planes by comparison of common features. At left (fractograph 3534) is a typical facet of a basal (0001) plane, with broad diagonal bands that are intersected at right by the secondary cleavage facet that is shown in the fractograph at right (3535). Reference to the faces of a model of a bismuth crystal permits explicit identification of the broad bands as {10 $\bar{1}$ 4} twins, the vertical laminae as {0001} planes, and the secondary cleavage facet as a (10 $\bar{1}$ 1) plane.

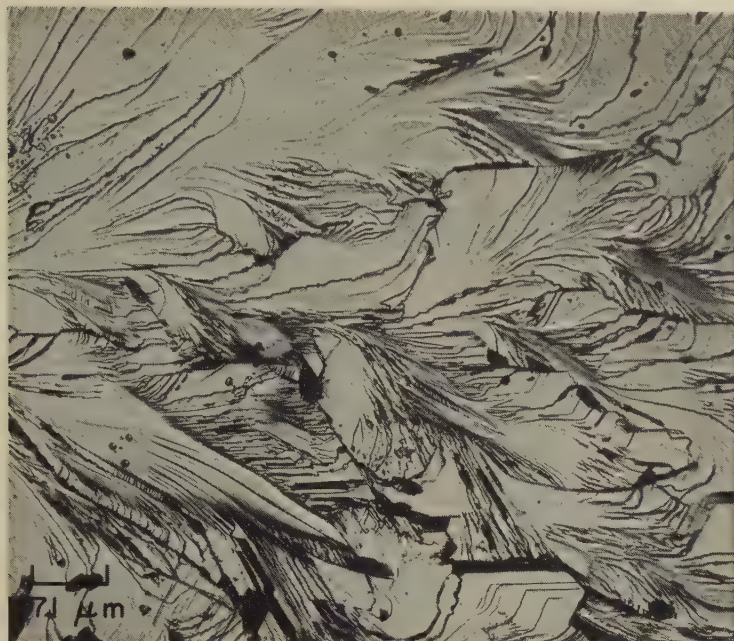
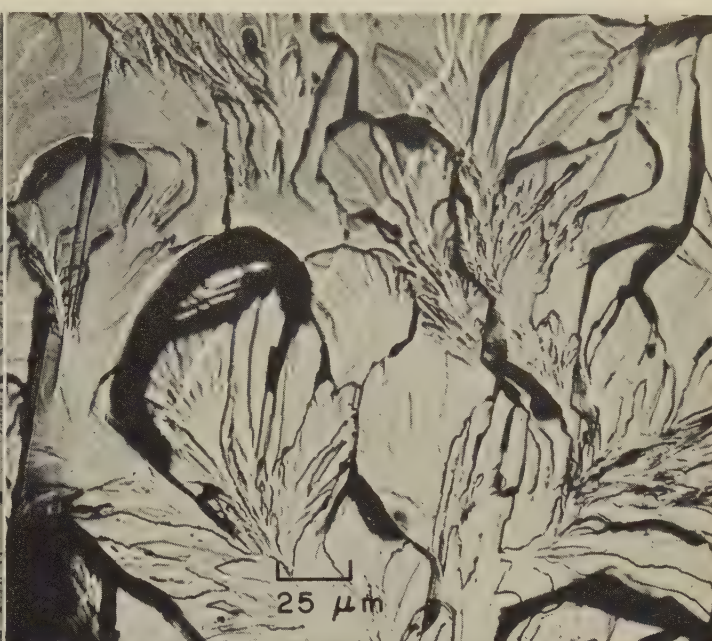
3537, 3538

Two similar fracture surfaces of as-cast specimens of antimony-bismuth alloys having markedly different compositions. Specimens were prepared by furnace cooling the molten alloy from 700 C (1292 F) and then were broken by impact at room temperature. Specimen at left (fractograph 3537) analyzed 89.79% Sb, 9.89% Bi, 0.22% As; it shows a basal-plane type of cleavage facet with departures from a true plane that resemble river patterns. Specimen at right (fractograph 3538) analyzed 89.51% Bi, 10.35% Sb, which is nearly an analogue of the composition of the specimen at left. Allowing for the difference in magnifications, the fracture surface in 3538 is remarkably like that in 3537, showing a complex system of cleavage steps that separate smooth, nearly perfect planar areas.

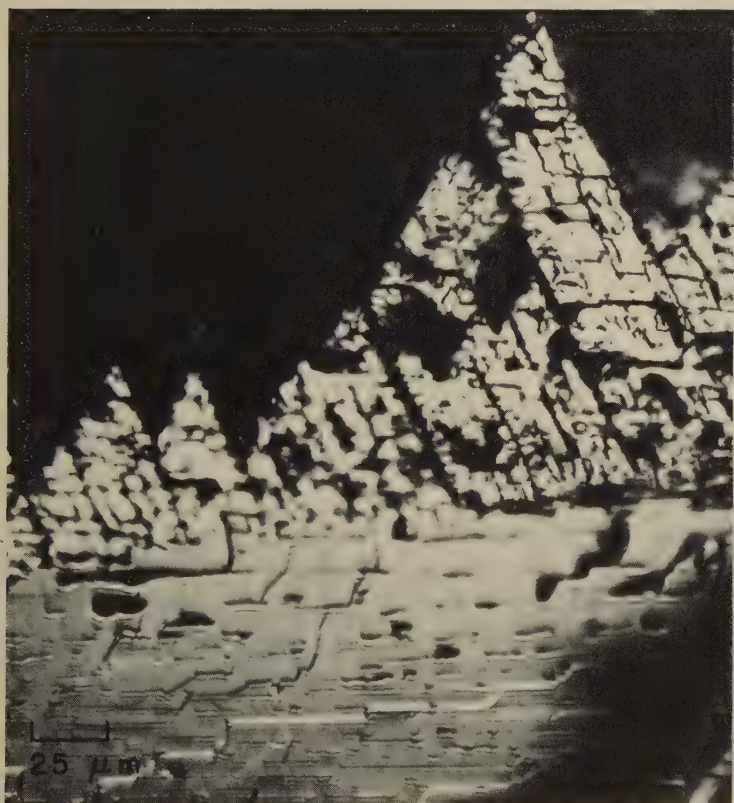
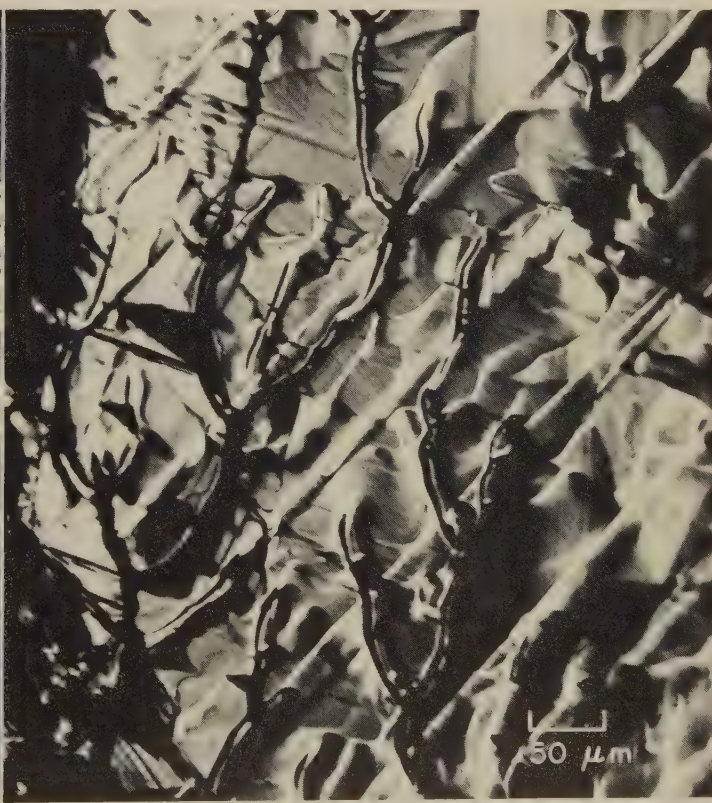
3539, 3540

Two markedly different fracture surfaces of specimens of bismuth-zinc alloys with similar compositions. Both specimens were melted under helium, superheating in fused-quartz tubes to 500 C (932 F) before freezing, and were fractured by impact at -196 C (-321 F). Specimen at left (fractograph 3539), of 97% Bi-3% Zn, displays an area (above center) of unusual trigonal symmetry; in the area below center, excess zinc (eutectic composition is near 2.7% Zn) may have been enclosed in the eutectic. Specimen at right (fractograph 3540), of 96% Bi-4% Zn, consists of a complex array of zinc-rich dendrites in a eutectic matrix; note the 60°-related angles between the secondary planar fissures. Fractograph 3540 was made using special oblique illumination.

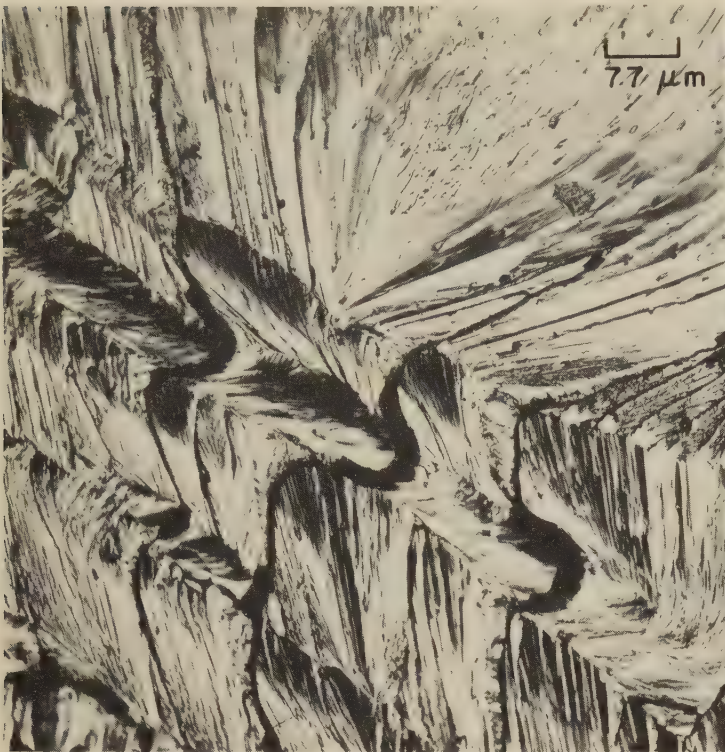
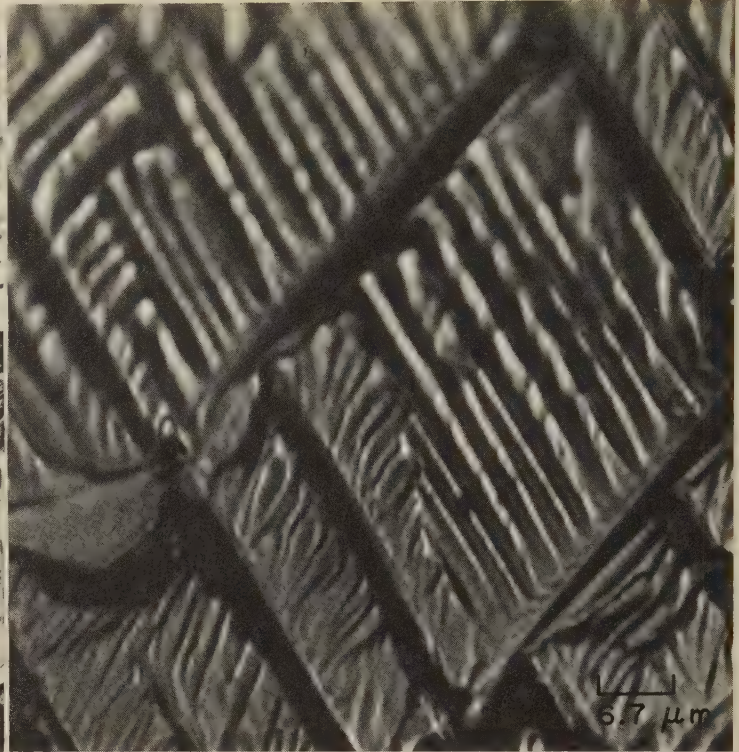
3541, 3542 Two views of an impact-fracture surface of an as-cast specimen of forgeable high-carbon molybdenum. Specimen was made by vacuum-arc melting pressed molybdenum powder, deoxidizing the melt by addition of 0.04% C, and then chill casting on a water-cooled copper starting plug. Fracture was by a single blow at room temperature. Fractograph at left (3541) shows a transgranular facet with a complex rupture path that may reflect the influence of chill casting. Fractograph at right (3542) is a highly magnified view of a facet that is believed to contain cleavage and twinning. Dark boundaries in 3542 may be cleavage steps; light ridges may be twins lying at angles of about 67° , which is consistent with mutual intersections of the $\{112\}$ family of planes.

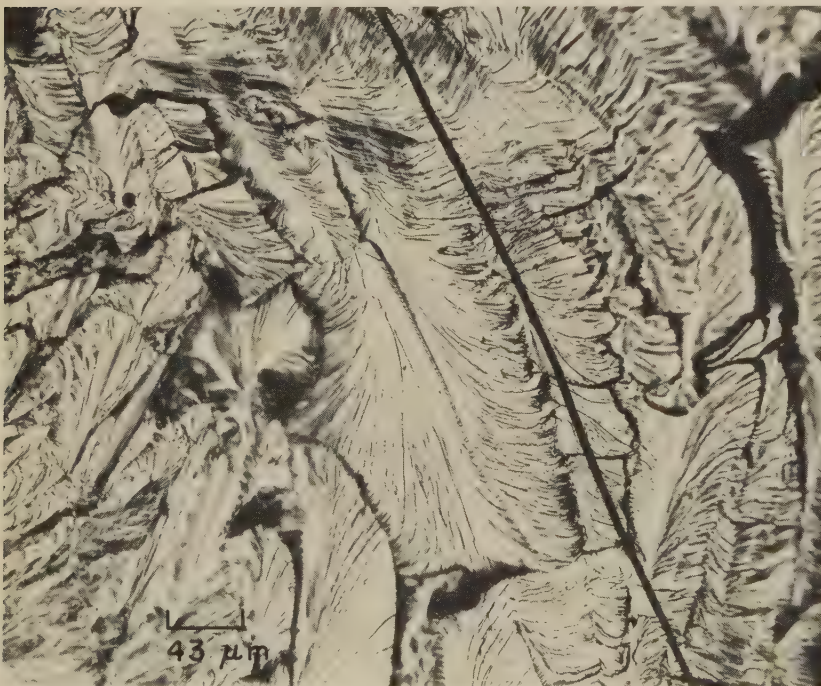
3543 Surface of an impact fracture in a vacuum-arc-cast specimen of high-oxygen molybdenum that was cold worked after casting, by hammering, then broken at room temperature. Preheat of the melt was to 2600 C (4712 F). Region at upper left resembles the fracture details at lower left in fractograph 3541. The many separate crack fronts are in sharp contrast to the smooth secondary cleavage that slopes to lower right.

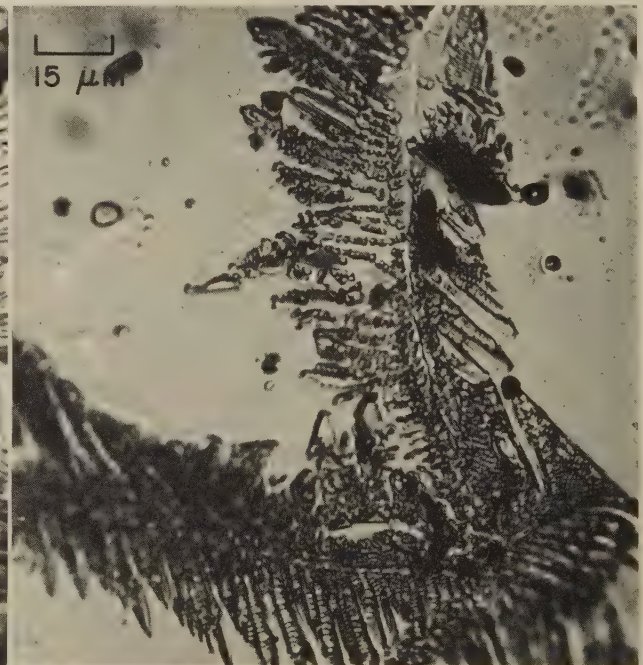
3544 Room-temperature impact fracture in vacuum-arc-cast molybdenum that contained high oxygen and was not forgeable. Cleavage has exposed an internal penetration of MoO_3 along both sides of what is believed to be a grain boundary. The MoO_3 inclusion appears as a beaded and fernlike growth, probably on an intergranular surface. See 3548, on the opposite page.

3548 View of a different area in the fracture surface of the high-oxygen, vacuum-arc-cast molybdenum specimen in fractograph 3544 (facing page), showing a less common form of molybdenum oxide than the granular structure visible in 3544. This oxide inclusion has a structure similar to a palmetto leaf, and indicates an extremely advanced stage of oxidation.

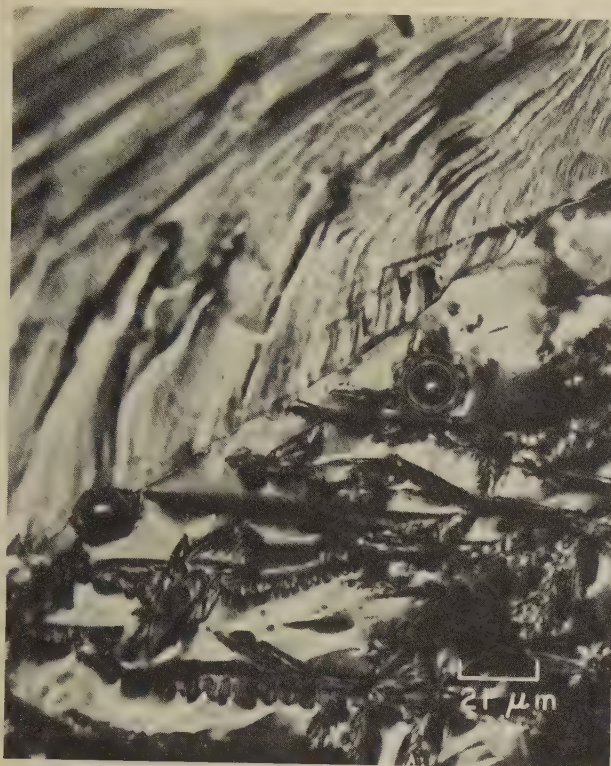
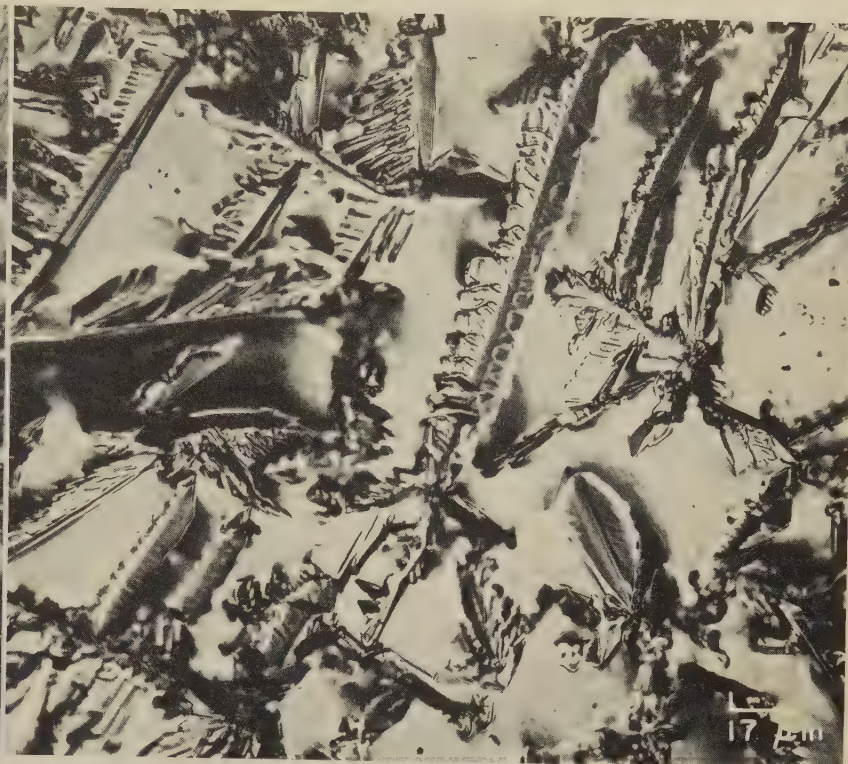
3545, 3546 Two views of the surface of an impact fracture in a specimen of vacuum-arc-cast molybdenum that was broken at room temperature, displaying different fracture mechanisms. At left (3545) is a composite fractograph of an area in which the crack front entered from upper right as a transgranular separation but, on encountering the diagonal grain boundary, was abruptly deflected and changed to an intergranular separation. The deflection was so great that both facets could not be brought into simultaneous focus, and two exposures were necessary. The lower facet in 3545, and the view of the fracture surface in 3546, both display featherlike carbide inclusions against featureless separated-grain surfaces. (See 3547, below, for a high-magnification view of one of these carbide "feathers".) The spheroidal features in 3545 are gas cavities.

3547 A high-magnification view of a molybdenum carbide "feather" precipitated at a grain boundary in an impact-fractured specimen of vacuum-arc-cast molybdenum. These grain-boundary carbides, which are visible in the lower part of composite fractograph 3545 and in fractograph 3546, do not represent any harmful effect on the forgeability of cast molybdenum.

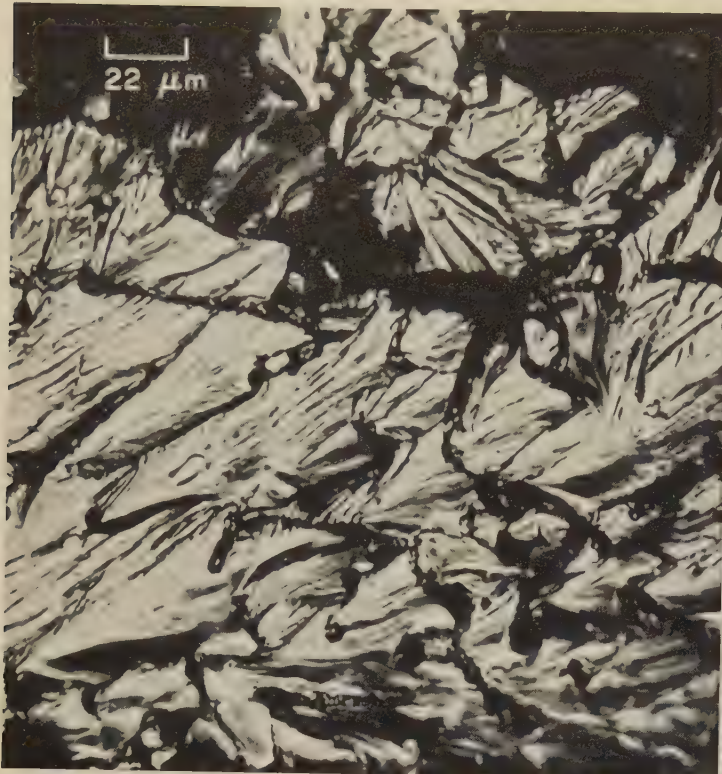
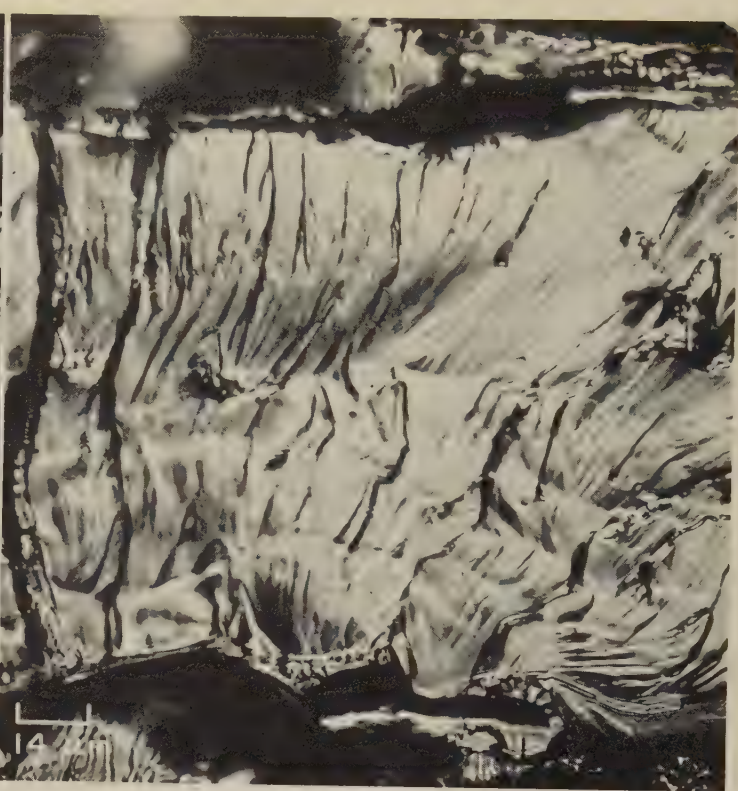
3549, 3550

Two views of the surface of a room-temperature impact fracture in a specimen of vacuum-arc-cast tungsten that was deoxidized by addition of 0.04% C to the melt. Fractograph 3549 (left) shows a system of cleavage facets separated by pronounced cleavage steps. Many of these steps originated at small pits or inclusions. Fractograph 3550 (right) reveals a more regular region of the fracture surface, showing many markings that cross the direction of crack propagation. These markings may have resulted from brief pauses in crack growth or from changes in crack-growth direction caused by microstructural features. At bottom in 3550, tungsten carbide inclusions are visible at a grain boundary. These inclusions faintly resemble the molybdenum carbide inclusions in 3545, but there is no suggestion here of the wide distribution of carbides that is evident in 3545.

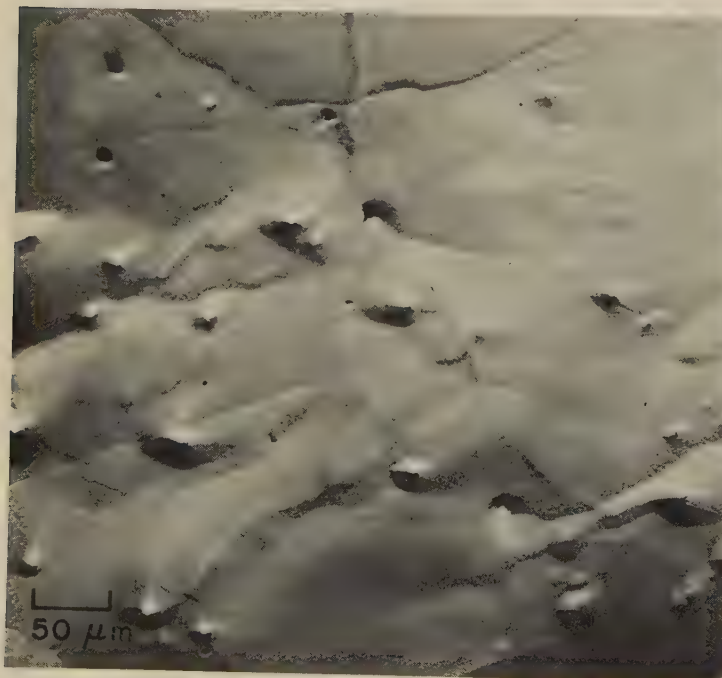
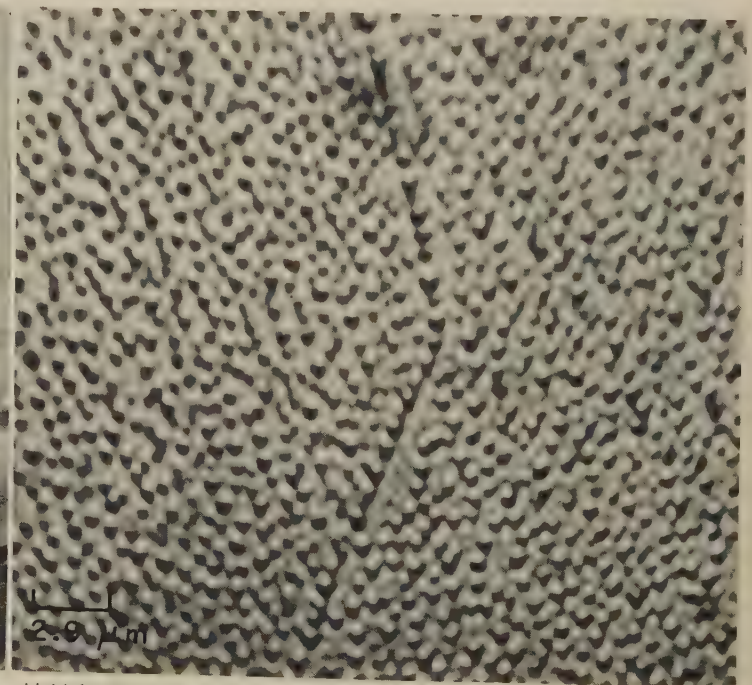
3551, 3552

Two views of the surface of a room-temperature impact fracture in a specimen of vacuum-arc-cast tungsten that was deoxidized by adding 1.0% Al to the melt. The fracture was intergranular, as shown in 3551 (left). Many fine grain boundaries or subgrain boundaries are visible. Several gas cavities are present; the protuberances presumably are inclusions. The fine grain boundary. See also fractograph 3553 (on the opposite page).

3553 Surface of a room-temperature impact fracture in a specimen of the same aluminum-deoxidized tungsten as in 3551 and 3552. Here, fracture was by transgranular cleavage. The diagonal lines are crystallographic markings that show that the differently shaded zones are regions of a single grain. The jagged lines are a precipitate, possibly Al_2O_3 .

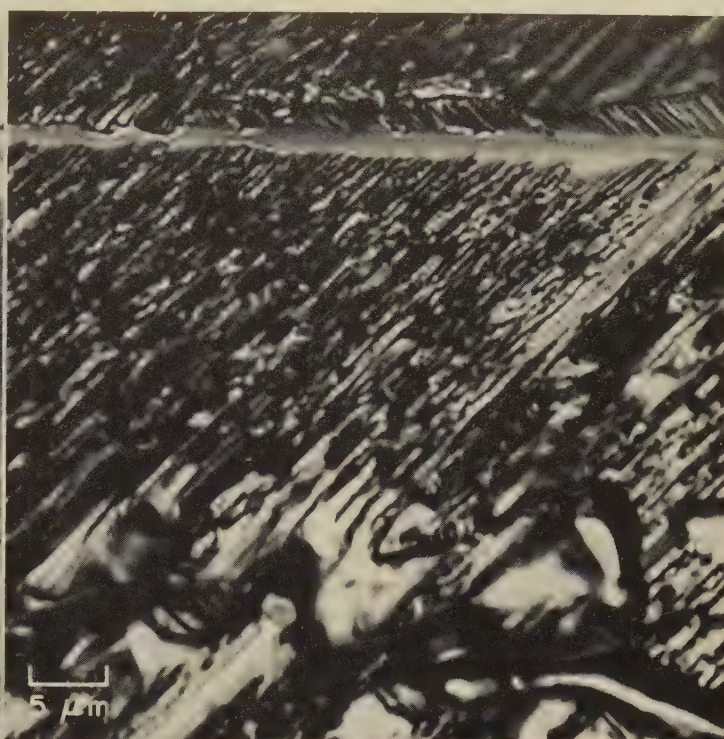
3554 Surface of a room-temperature impact fracture in a specimen of vacuum-arc-cast tungsten deoxidized by adding 0.04% C to the melt, showing crystallographic fracture patterns involving a spine (near top of fractograph). In spite of its appearance, the demarcation at bottom is not a grain boundary, because the fracture lines cross it unaltered.

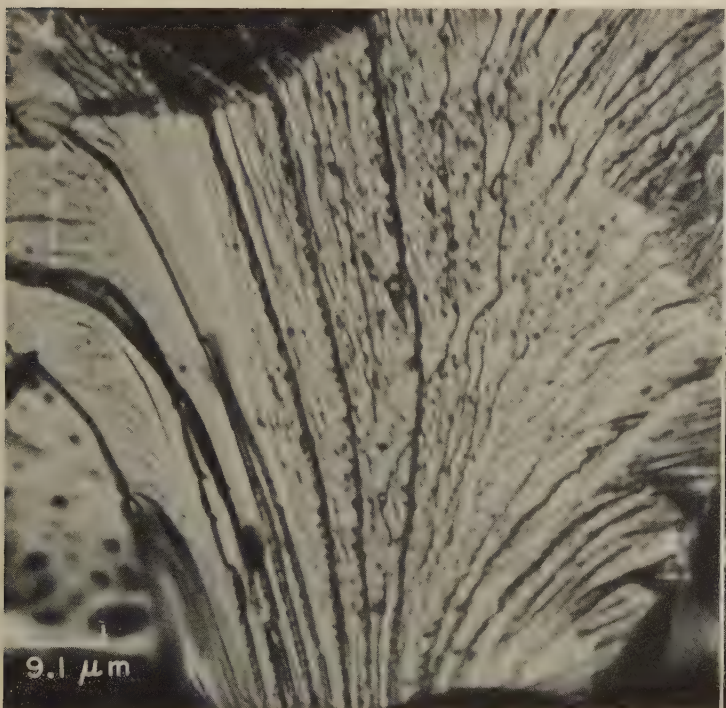
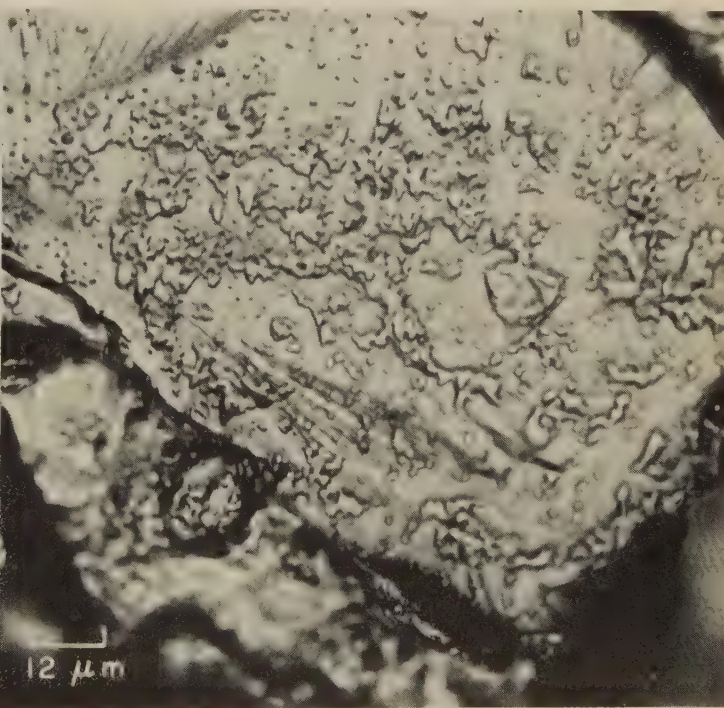
3555, 3556 Surfaces of room-temperature impact fractures in two tungsten rods prepared by hot swaging compacts of high-purity tungsten powder containing a small percentage of rare earths (99.9+ % W, <0.02% R_2O_3). In 3555 (left), the presence of pits and particles in the central region suggests incomplete densification; the fracture patterns at left and at right closely resemble those in cast metal. In 3556 (right), it is evident that incomplete bonding was achieved in swaging, leaving small islands of coalesced powder not joined to the major grain. These islands provided paths of weakness that determined the entire fracture path, producing in a sense an intergranular fracture.

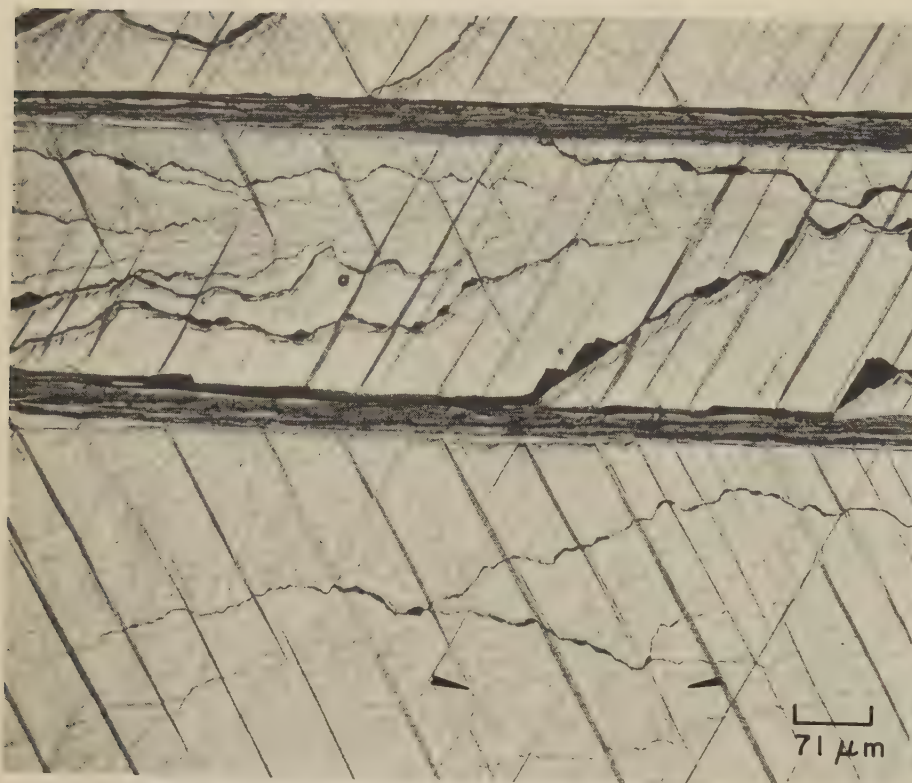
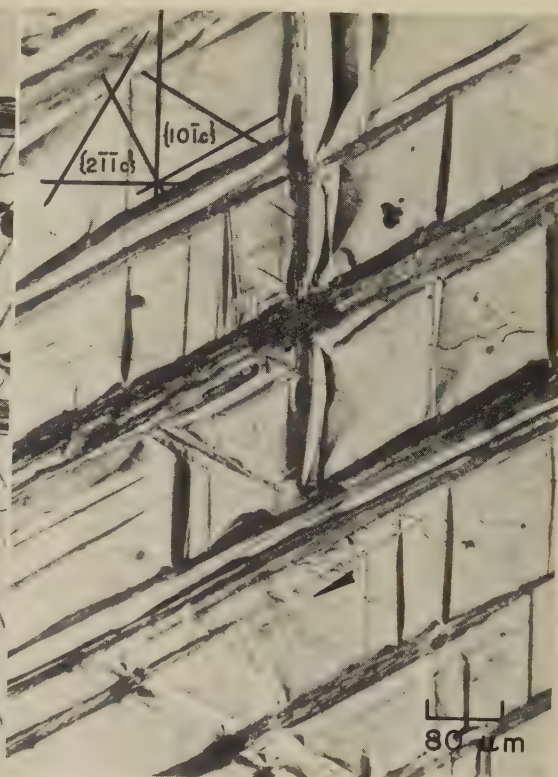
3557, 3558

Two views, each showing a basal plane (0001) cleavage facet in a single grain in impact-fracture surfaces of polycrystalline specimens of CP-grade zinc broken at room temperature. In fractograph 3557 (left), the heavy horizontal marks are $\{10\bar{1}c\}$ twin bands; the lighter, diagonal marks are either twin or kink bands; and the faint vertical lines (at arrows) may be tracings of $\{11\bar{2}c\}$ planes. Specimen in fractograph 3558 (right) was heavily deformed in compression before being fractured. This view shows heavy vertical and diagonal $\{10\bar{1}c\}$ twin bands plus accommodation kink bands, and (at arrow) light traces of $\{2\bar{1}\bar{1}c\}$ planes at 60° to horizontal.

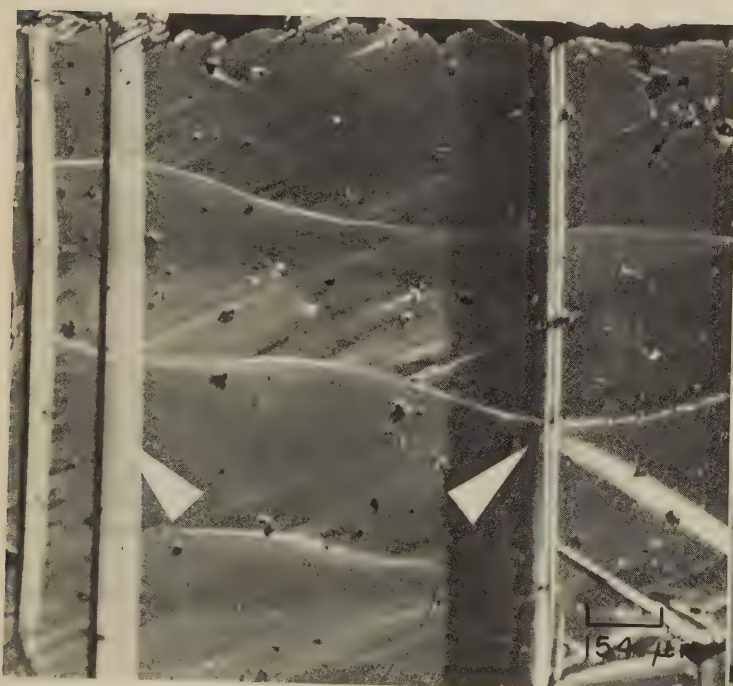
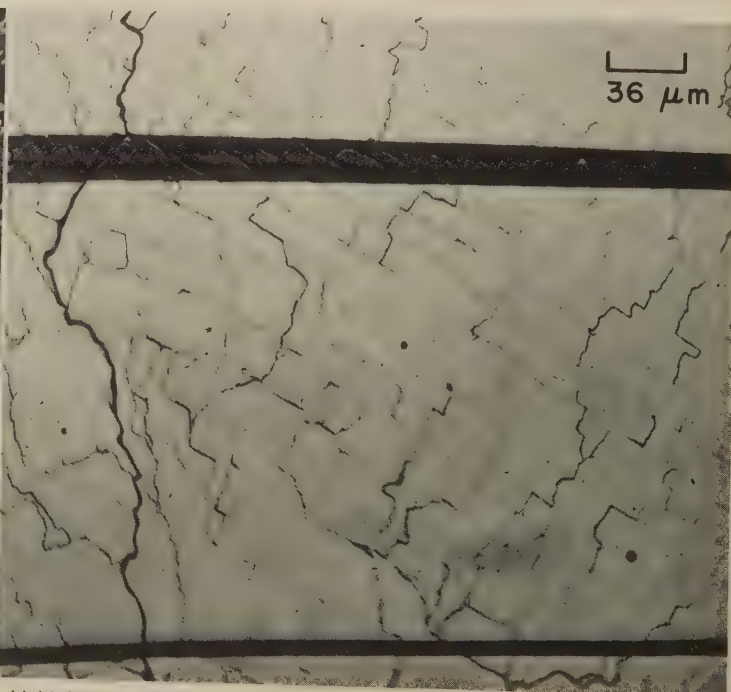
3559, 3560

Impact-fracture surfaces of two specimens of 99.999% zinc that were broken at room temperature. At left (fractograph 3559) is the basal cleavage of a single crystal, photographed with an opaque-stop metallograph, showing a pair of twins (at arrowheads) with opposite slopes. The shading also indicates opposite slopes for the accommodation kink bands adjacent to the twins. Fractograph 3560 (at right) is of a cast polycrystalline specimen. The light, diagonal traces may be of a $\{11\bar{2}c\}$ form that is akin to the faint vertical markings at the arrows in fractograph 3557; note that these traces deflect the many fine secondary fissures but that the dark, horizontal bands are entirely unaffected.
